TOWN OF STAMFORD

Hazard Mitigation Plan

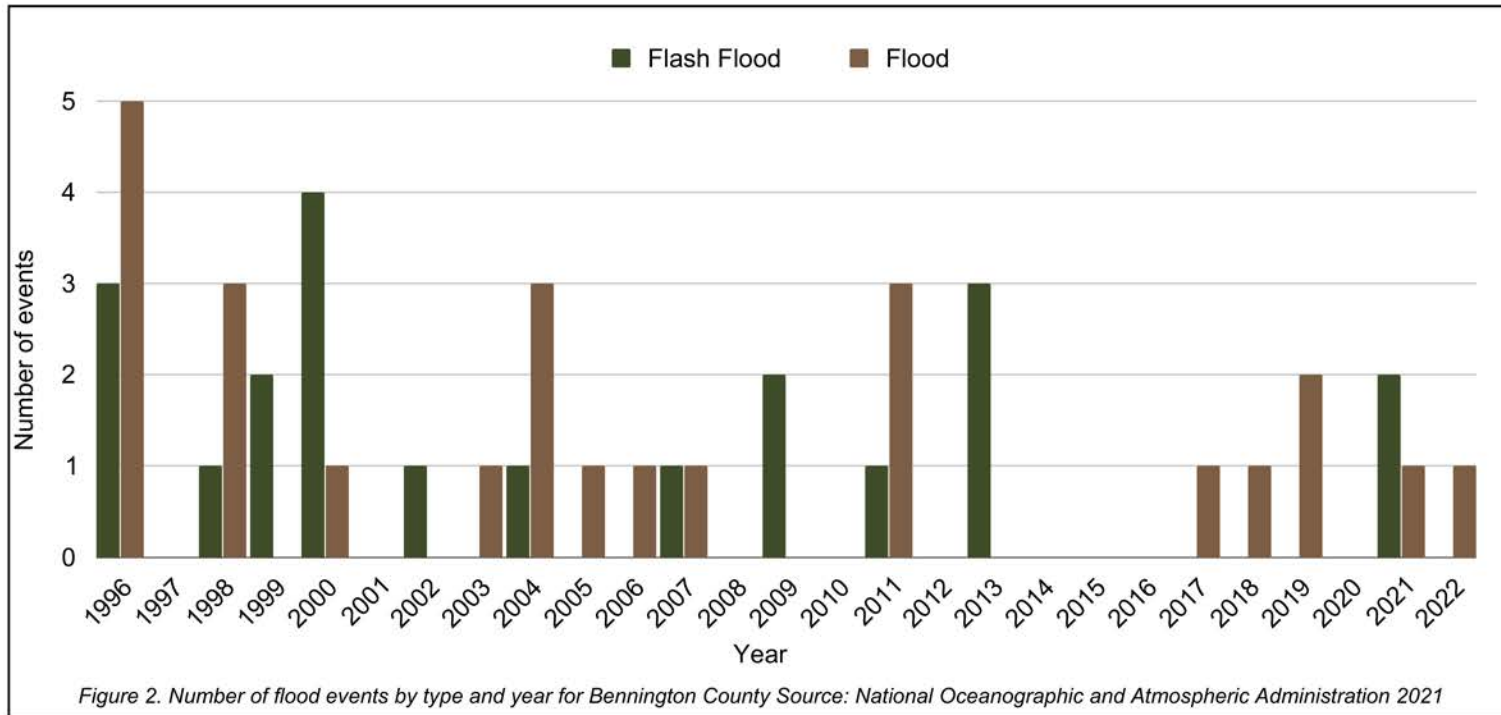
Figure 2 shows a total of 48 flood events in Bennington County from 1996 to 2022, using NOAA data. These have been primarily minor and affected either specific streams, such as the Walloomsac and Batten Kill, or a specific town or towns.

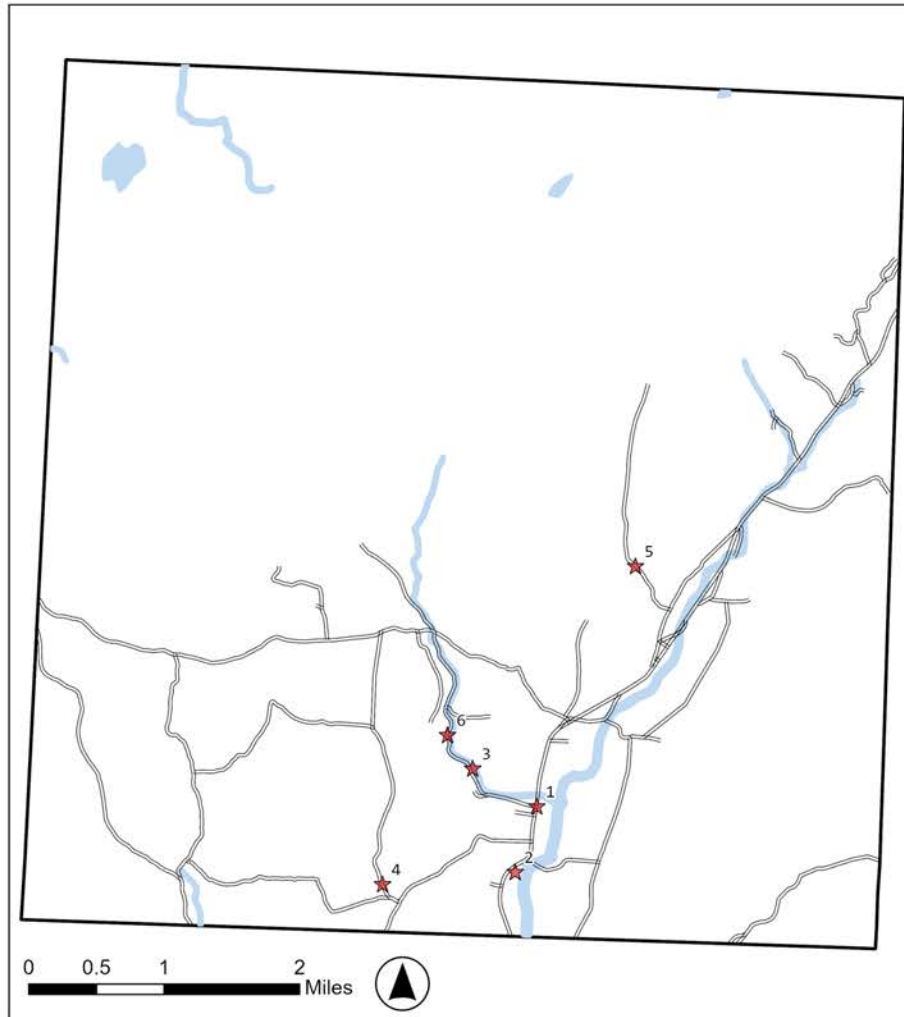
Map 7: Hazard areas in Stamford VT Source: Bennington County Regional Commission, 2023

Map 7 is a composite map showing areas identified by the planning team as vulnerable to flooding, steep grades, and areas needing major culvert upgrades. Other priority hazards were not mapped either as adequate surveys have not been completed, or they could affect the entire town. Table 20 lists the hazard areas, shown on Map 7.
